**Tanana Chiefs Conference  
Galena Clinic Foundation Assessment  
Galena, Alaska**

**Foundation Assessment**

**Tanana Chiefs Conference  
201 1<sup>st</sup> Avenue  
Fairbanks, Alaska 99701**

**July 31, 2023**

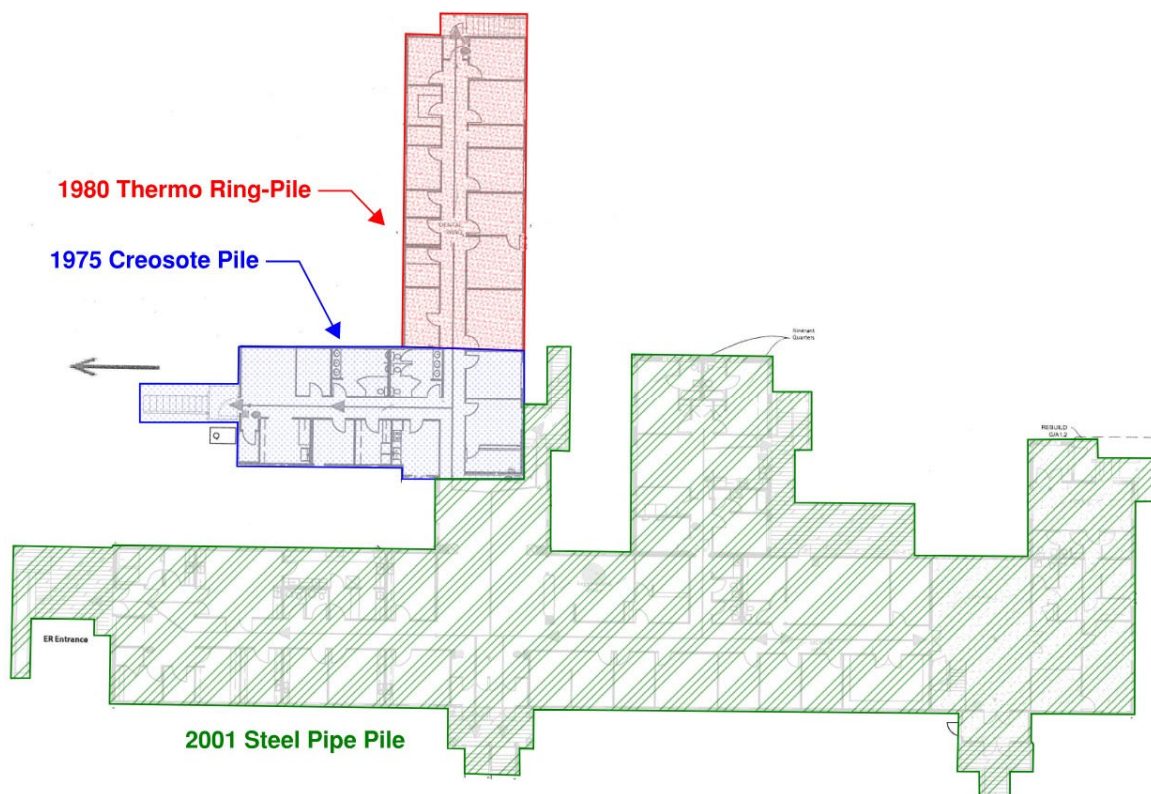
Figure 1: Pile Foundation Type Layout

The approximately 16,000 square foot structure owned by the City of Galena is occupied by both the city hall and by the health clinic run by the Tanana Chiefs Conference, the clinic occupying most of the space. The building is of wood framed construction supported atop heavy glulam beams spanning between piles. Three distinct pile foundation types correlate to the three phases in which the structure was built:

1. The oldest wing constructed around 1975 is supported atop large-diameter creosote piles embedded approximately 20-feet below grade.
2. In 1979 to 1980, work began designing and constructing the second wing, which is built on 6-inch diameter Thermo Ring-Piles supplied by Arctic Foundations, Inc. of Anchorage, Alaska. Based on the original shop drawings which are attached for reference, these piles are approximately 21 feet-6 inches from pile tip to the base of the pile cap assembly. Based on the exposed portion, the actual embedment of the piles is estimated to vary from 15 feet at the east end to 18 feet at the west interface with the general services wing.

3. The final and largest addition added between 2001 and 2003 is supported on 8-inch diameter steel pipe piles. The depth and installation method of these last piles is unknown because the City of Galena contracted out the pile installation to a local contractor separate from the main building design.

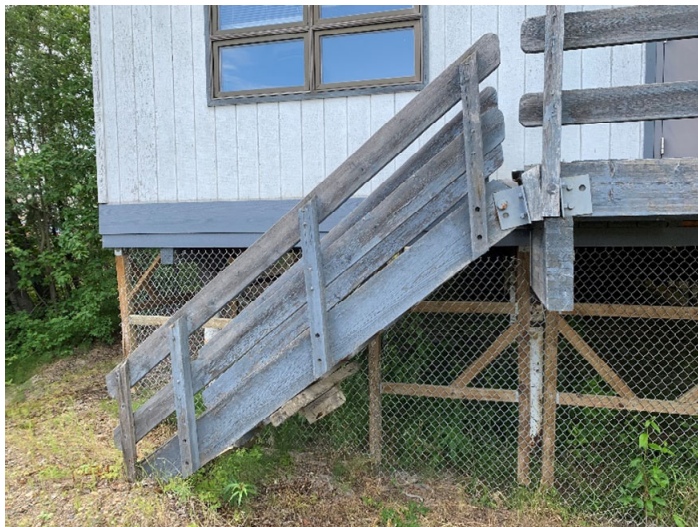
The emergency exit stairs at the east end of the dental clinic have soil subsidence at their base. This has caused distress at the upper connection to the deck and has increased the slope of the stairs. These

stairs should be rehabilitated to maintain safe emergency egress from the offices and exam rooms at this and of the clinic.

*Figure 2: Distressed Stairs at East End of Dental Clinic*

1. Build up grade around stairs and ramps as required to ensure proper support and safe egress.
2. Install temporary steel members to bypass failing threaded rod supports to allow time to investigate and design a permanent retrofit for piles.
3. Mound soil around base of Thermo Ring-Piles to reduce water intrusion.

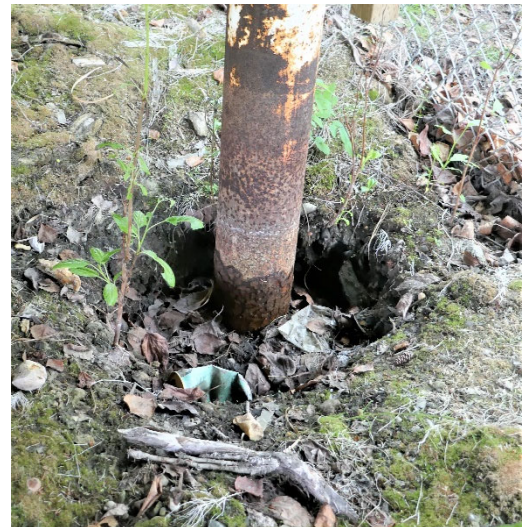
Depressions are forming in the ground around many of the piles. These depressions were also noted in 1997 by Edward Yarmak, PE, of Arctic Foundations, Inc. He recommended mounding soil around these piles to reduce water infiltration at the pile, substantially improving the late summer capacity. In addition to the local depressions at the piles, the ground surface also slopes to underneath the east end of the dental clinic wing. Likely coincidentally, this portion of the clinic also has the greatest differential movement.

*Figure 3: Depression Around Thermo Ring-Pile*

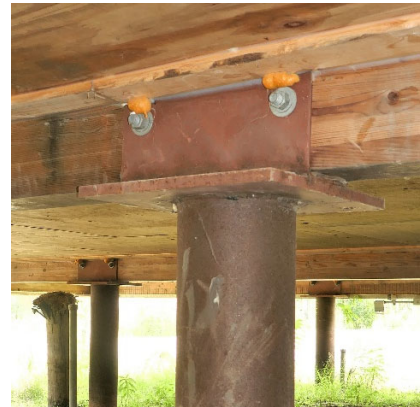
The original pile cap configuration is a structural steel beam saddle welded directly to the pile. This connection provides robust lateral and gravity load transfer from the floor structure to the foundation but allows for no adjustment.

Figure 4: Original Main Clinic Pile Cap

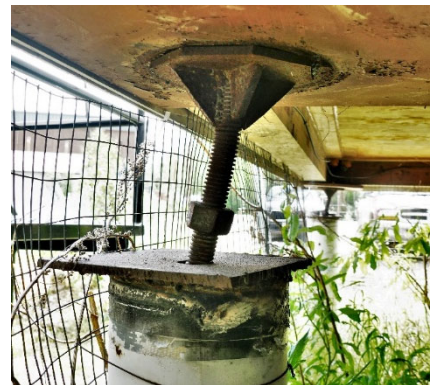
Since original construction, some of the piles beneath the city hall and the itinerant quarters have been cut free of the beam saddle and retrofit with a poorly designed adjustable pile cap. This assembly is made up of a single 1-1/4 inch diameter threaded rod welded to a cap plate and bearing on a single nut at a plate welded to the pile. The cap plate is welded to the beam saddle. There is no positive attachment to the plate at the pile. Many of the retrofits are beginning to fail. Where this cap is used at the deck support piles, it is beginning to roll. At one heavily loaded main building pile, the load is deforming the 1/4-inch pile cap plate downward where the threaded rod and nut bear. Along the south and east perimeter of the itinerant quarters, this pile cap assembly is overextended, and the threaded rod is bending. This yielding appears to be worsened by lateral displacement of the pile. Additionally, at these locations, the nut on which the assembly typically bears is no longer in contact with the cap plate.

Figure 6: Failing Adjustable Pile Cap

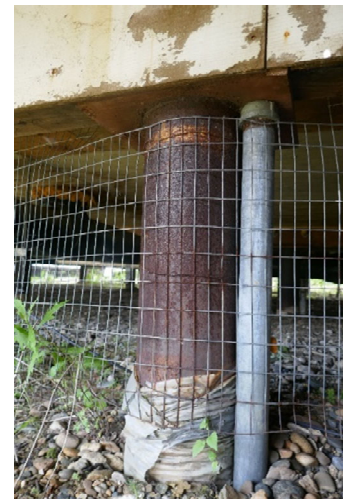
Each of the steel piles at the main clinic/city hall addition have galvanized pipe thermistor tubes installed beside them. In some locations, these tubes are jacking and getting close to the underside of the structure.

Figure 5: Frost Jacking Thermistor Tube
